HOME INSPECTION REPORT

Your Address Here

01/01/2018

Report Number:

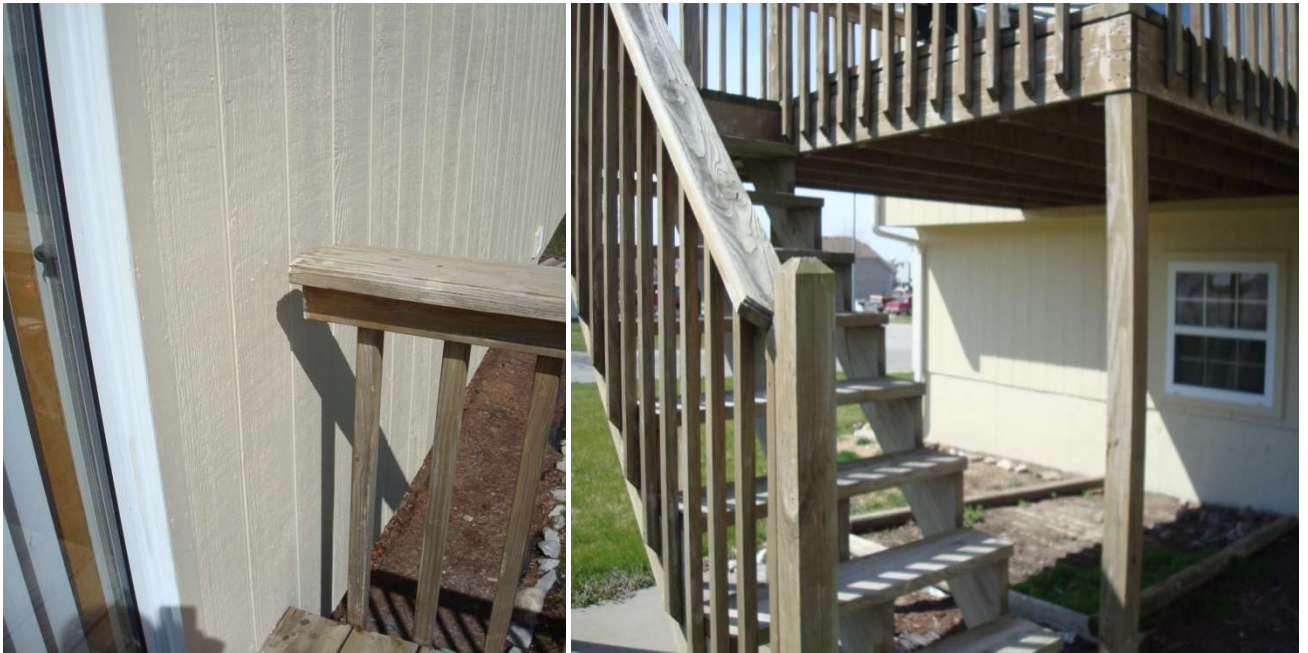
Railing recommended on steps - SAFETY CONCERN.
Railings loose - SAFETY CONCERN.
Deck supports are bowed and cracked-Recommend repair
Front stoop step risers are uneven may present a trip hazard.
Recommend additional backfill to create a proper pitch away from the house.

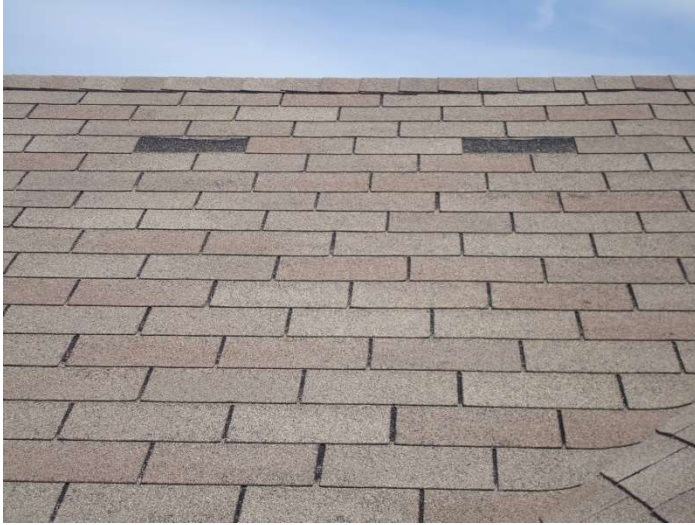
Missing tabs or shingles in need of repair or replacement.
Replacement within 5 years.
